IMAGES IN INTENSIVE MEDICINE

Anomalous position of femoral dialysis catheters

D. Arias-Verdu, G. Seller-Pérez, M.E. Herrera Gutiérrez*

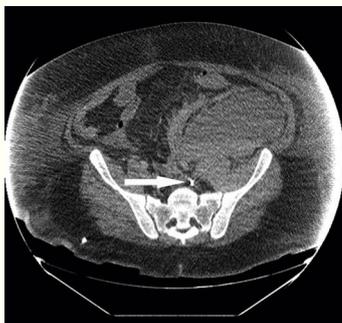
Figure 1

A patient underwent CRRT through a left femoral vein catheter (34 cm–13.5 F). Immediately after the insertion we detected problems in the circuit blood flow and the patient deteriorated. A CT scan showed the tip of the catheter in the left lumbar vein beside a retroperitoneal haematoma (Fig. 1). Another patient (same catheter and insertion technique) showed persistent blood flow problems and in a CT scan the catheter was detected in an accessory left hemiacygos vein and already visible in the plain abdominal x-ray (Fig. 2). Because presumably an eco-directed insertion would not have prevented these anomalous locations, in the event of serious flow problems, a radiologic exploration can help ruling out this unusual and scarcely reported malposition that demands immediate withdrawal of the catheter.
