IMAGES IN INTENSIVE MEDICINE

Thoracic aortic injury caused by chest tube[☆]

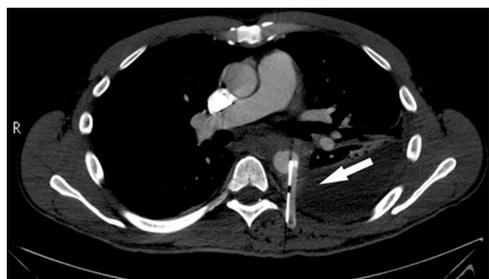
Figure 1

We hereby present the case of a 45-year-old male admitted to the ICU due to parapneumonic pleural effusion at the organizing stage in his left lung. The introduction of a pleural catheter to drain the lung is followed by arterial blood coming out of the catheter that is clamped and rapidly fixated. An urgent CT scan is conducted. The CT scan shows the excessively medial insertion of the catheter and the tip resting inside the descending thoracic aorta (white arrows, [Figs. 1 and 2](#)). The cardiovascular surgeon on call is then notified. He decides that the best therapeutic option is endovascular treatment. One thoracic endoprosthesis is then introduced through the patient's left femoral and, in a coordinated maneuver, the drainage catheter is removed and the prosthesis deployed to close the solution of continuity ([Fig. 3](#)). The case is a clear example that any invasive technique can have serious complications. If the catheter had been removed during the puncture the consequences would have been fatal.
