IMAGES IN INTENSIVE MEDICINE

Echo-guided left internal jugular vein central venous catheter insertion, with its tip in the left internal thoracic vein

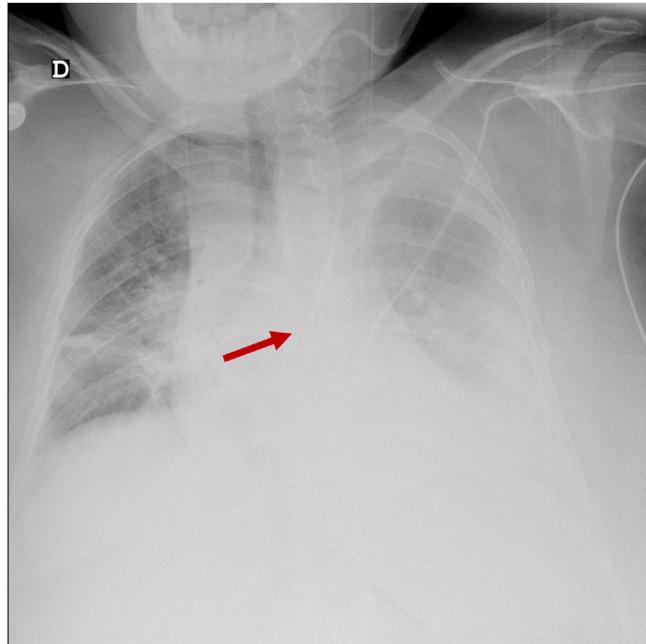
Figure 1

Although echography guidance can increase the success rate of central venous catheter (CVC) placement, it only ensures that the catheter is correctly placed at the level of the vessel entrance. Once the guidewire is inserted there is little we can do to ensure its correct direction on a simple procedure like this one. This is the example of this patient, with left pneumonic empyema in which x-ray confirmation showed CVC migration (Fig. 1). Anecdotally, the only adverse effect reported from this misplacement was acute chest pain on fluids bolus infusion. On chest computed tomography scan, the catheter can be seen going down the left jugular vein and straight inside the brachiocephalic vein (Fig. 2 star) toward the left internal thoracic vein (Fig. 2 arrow).
