IMAGES IN INTENSIVE MEDICINE

Pulmonary vein stenosis after valve replacement surgery[☆]

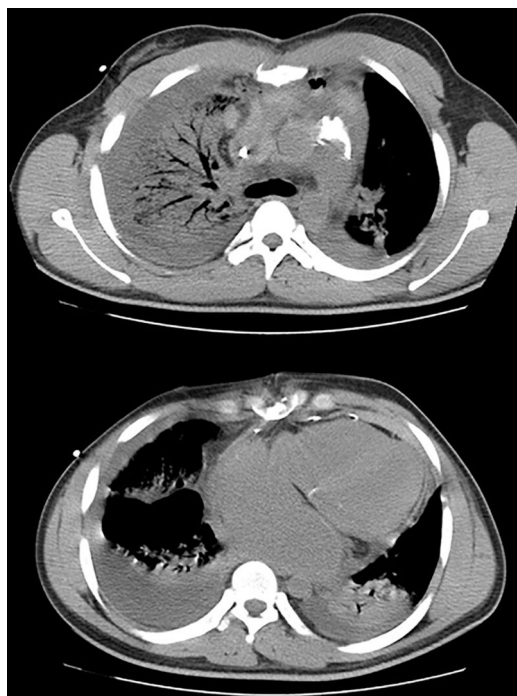
Figure 1 Computed tomography scan: alveolar consolidation at the level of the right upper lobe of the lung and moderate mediastinal hematoma.

the immediate postoperative care following surgical mitral valve replacement. The diagnostic key was the development of respiratory failure and unilateral pulmonary edema. The axial chest computed tomography scan performed confirmed the presence of one alveolar consolidation at the level of the right upper lobe of the lung sparing the remaining pulmonary fields and one mediastinal hematoma (Fig. 1). This study was complemented with another study that used IV contrast and confirmed the collapse of the right pulmonary vein close to the junction of the right atrium (Fig. 2). Stenosis resolved after evacuating the mediastinal hematoma.

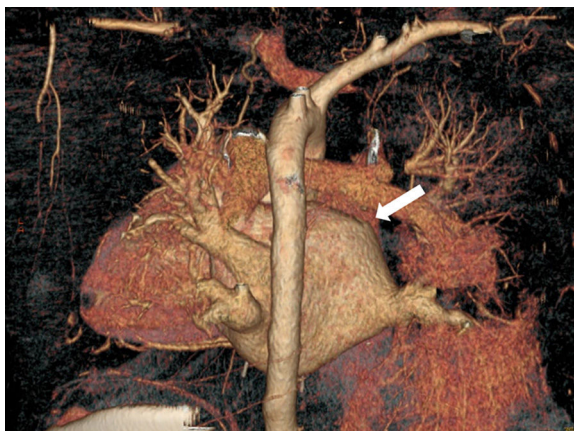
Figure 2 Computed tomography scan reconstruction with contrast: collapse of the right pulmonary vein close to the junction of the right atrium (white arrow).
